Caerphilly County Borough Council

NANT CYLLA

Scour Feasibility Study

DATE: FEBRUARY 2020

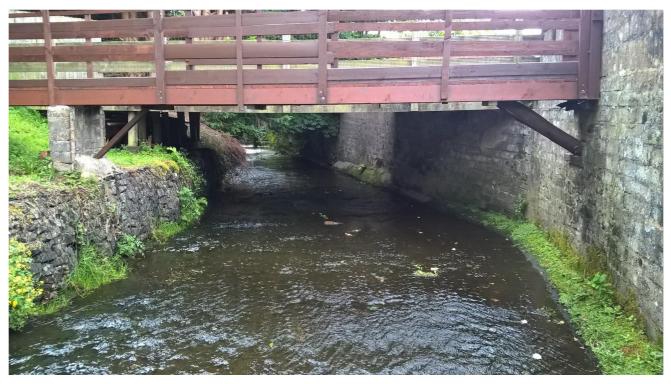
This section runs from the Commercial Street culvert outlet downstream to the concrete weir and recently repaired gabion walls in Section 2. In this section of the watercourse the bed of the channel is concrete lined and the bank retraining structures appear to be in generally good condition (a typical channel section is shown in Figure 2). The comparably smooth channel bed and banks in Section 1 allow water to be conveyed quickly downstream with reduced turbulence in the flow. The channel width in Section 1 is approximately 3m.

Figure 2 – Section 1: Concrete lined channel and bank retaining structures

In Section 1 the watercourse has a concrete apron which forms a continuous scour protection feature with the retaining features at each bank. This provides limited opportunity for scour to develop and as a result the channel bed and bank structures are in reasonable condition (compared with Sections 2 and 3) with no obvious signs of scour defects requiring immediate attention.

The recommended option in Section 1 is to install energy dissipation structures or baffles tied in to the bed and banks of the existing concrete lined channel.

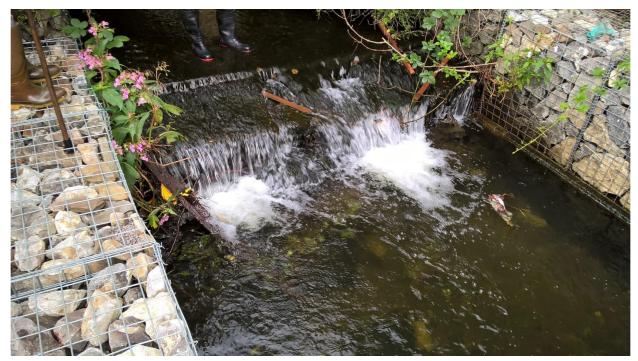
This transition area has been significantly affected by scour which resulted in failure in of the bank retaining structures in 2017. The gabion baskets collapsed and gradually fell into the river bed, restricting the cross-sectional area of the river. This area was repaired in the summer of 2018 with new gabions baskets installed on new concrete foundations and riprap was placed on the bed directly downstream of the weir. However, a subsequent high flow event in October 2018 caused the riprap

to be washed downstream and a large scour hole developed at the base of the channel immediately downstream of the weir, leaving the concrete foundations of the gabions baskets exposed to erosion and at risk of being undermined (see Figure 3 and Figure 4).

Figure 3 – Section 2: Concrete weir

The recommended option in Section 2 is to install an energy dissipation structure. The structure should be a rock weir type with embedded boulders.

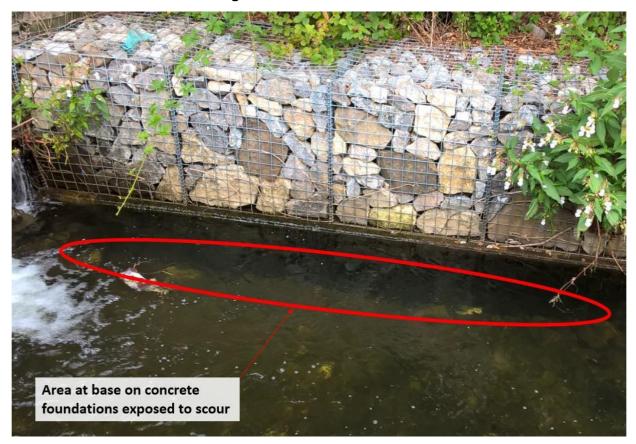
Figure 4 – Section 2: Gabion foundations exposed to scour

Section 2 has been significantly affected by scour. This resulted in the recent failure of existing gabion bank protection. Repairs were carried out in the summer of 2018 with new gabion baskets installed on new concrete foundations and rock (riprap) material placed on the channel bed. However, subsequently the riprap bed material was washed downstream, during a high flow event in October 2018 and a large scour hole has now developed in the channel immediately downstream of the existing concrete weir. In its current state the foundations of the recently installed gabion baskets are exposed to erosion and at risk of being undermined. Further intervention is therefore required to shore up existing scour protection structures in this location.

Undertake remedial works to replace the rock riprap material that has been recently washed downstream. Rock specification will need to be reviewed to ensure it can withstand high flow conditions and provide adequate energy dissipation. The feasibility of installing larger size riprap will need to be assessed.

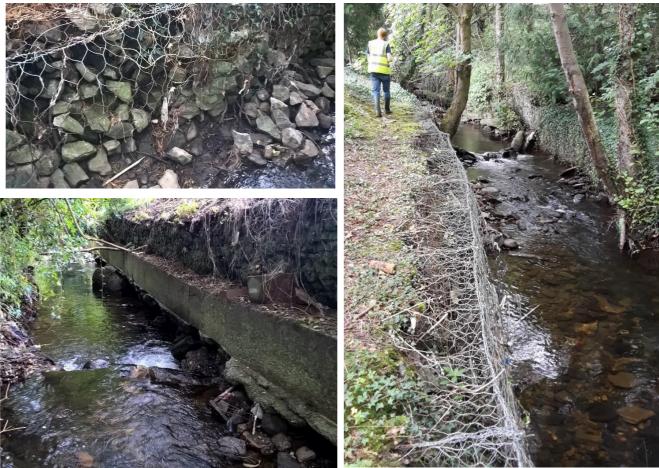
Downstream of the weir in Section 2, the river characteristics change. The bed of the river reverts to a more natural bed made of rocks and boulders. There is extensive erosion protection on both banks of the watercourse in Section 3 which constrains the channel laterally. The bank protection is a mix of rock filled gabions, rock filled gabions on concrete foundations, concrete walls and/or brick work in some locations. These protection measures are failing, and the ongoing effects of scour have exposed the concrete foundations in many locations, leaving the river banks at risk of undermining and collapse.

Figure 5 – Section 3: Typical photos of banks affected by scour

generally in a poor condition. Scour has exposed the concrete foundations and sub soil in places leaving the banks of the watercourse at risk of further undercutting and collapse.

The existing scour protection structures in Section 3 are in generally poor condition. Remedial engineering works are required along the whole of Section 3 to the confluence with the River Rhymney.

The recommended option for Section 3 is to widen the channel in combination with additional scour protection measures. The measures will include:

Enhanced renewal and replacement of existing scour protection measures, undertaking repairs where necessary, to improve the condition of the existing scour protection.
