Section 3: Natural bed & scour protection structures at banks. Significant signs of scour and failure of structures along reach.

## Appendix 1B

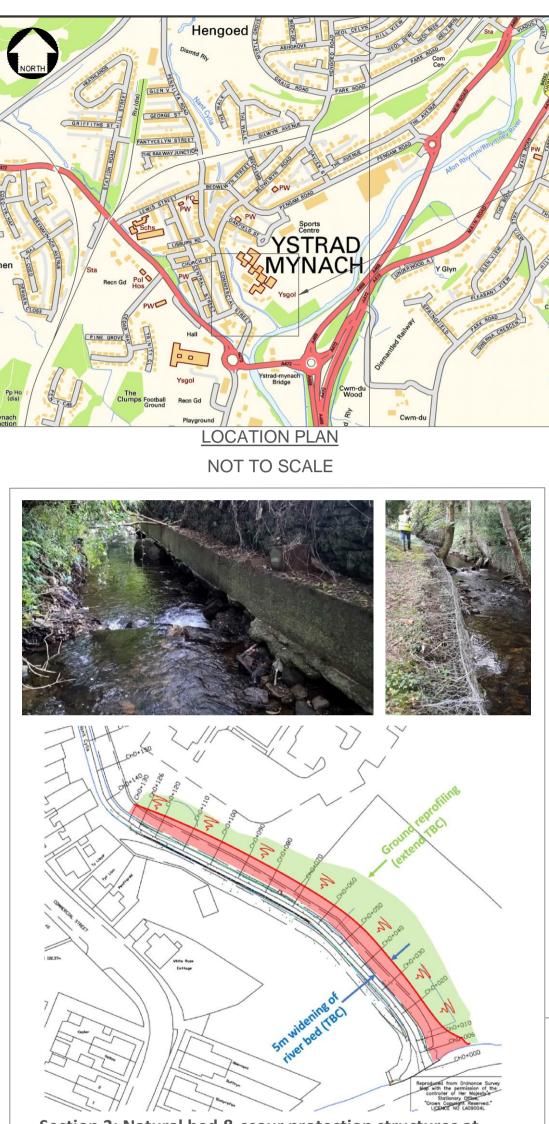
BY SCOUR
