Appendix 2	
Structure:	
Location:	ST 14715 94394

Location of Monitoring Points (Note: All photos to be taken looking upstream from locations)

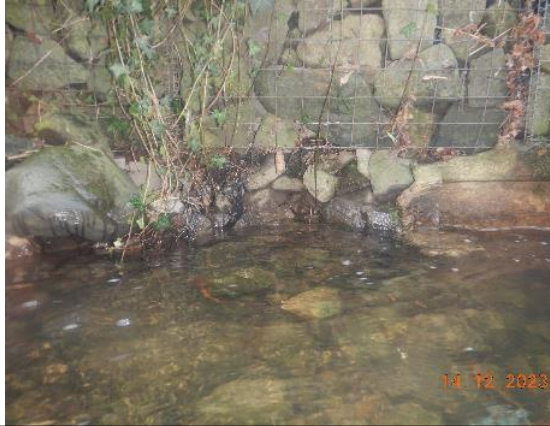
Photo 1

There was an area of scour to the base of the right gabion baskets (looking downstream) at the end of the concrete apron, previously measuring 700mm long, 320mm high and up to 180mm deep. However, there was evidence of attempts to fill the void with stonework since the previous inspection (photo 1).

Scour to the base of the right gabion baskets at the end of the concrete foundation (looking downstream)

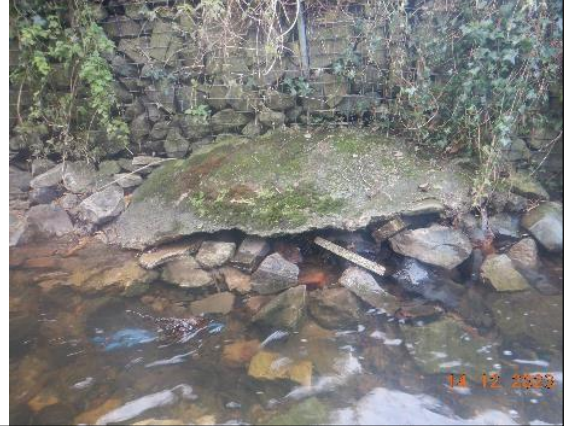
Photo 2

There was an area of scour to the concrete apron downstream of the right concrete foundation (facing downstream) previously measuring 2.2m long, 0.4m high and up to 0.77m deep. However, there was evidence of attempts to fill the void with stonework since the previous inspection (photo 2).

Scour to concrete apron downstream of right concrete foundation (facing downstream)

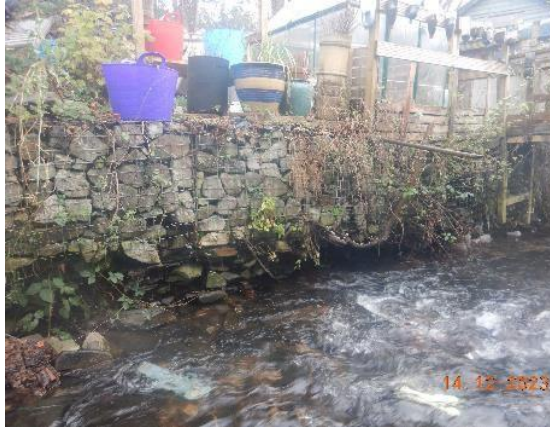
Photo 3

The gabion baskets downstream of the footbridge are undercut along their length with minor stone loss to the baskets at present (photo 3).

Scour to the base of the left gabion baskets downstream of the footbridge (looking downstream)

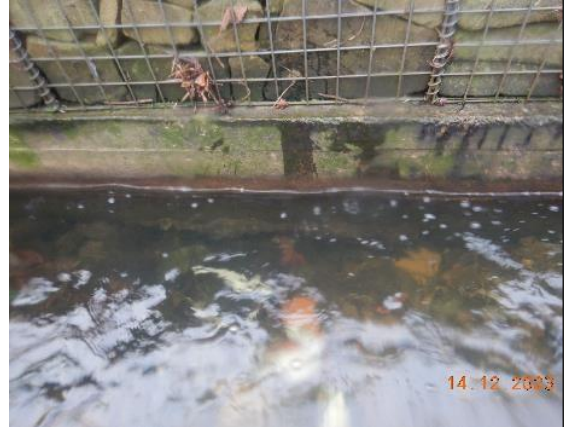
Photo 4

There was an area of scour to the right training wall (looking downstream), with the concrete apron undercut, measuring up to 2.9m long, up to 0.4m high and up to 0.6m deep. The area of scour did not appear to have deteriorated since the previous inspection (photos 4 – 6).

Concrete apron undercut along right training wall (looking downstream)

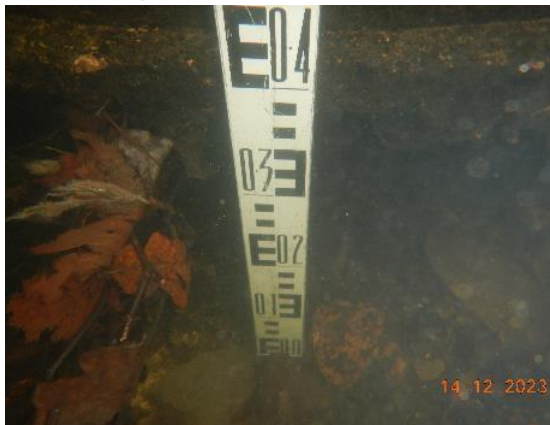
Photo 5

Concrete apron undercut along right training wall (looking downstream)

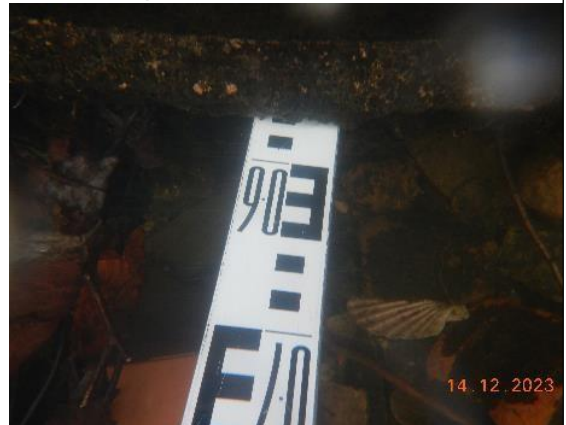
Photo 6

Concrete apron undercut along right training wall (looking downstream)

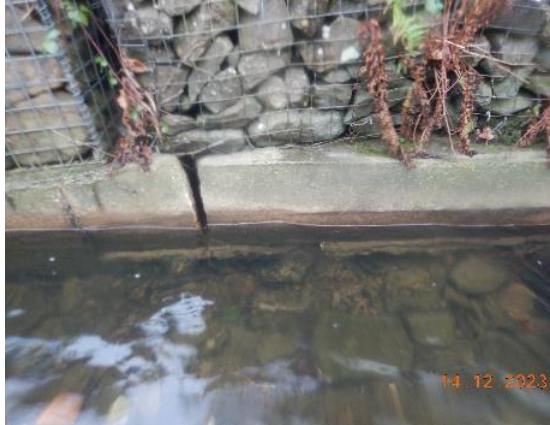
Photo 7

There was an area of scour to the base of the concrete foundation along the left training wall (looking downstream), measuring 2m long, up to 0.45m deep and up to 0.25m high. The area of scour did not appear to have deteriorated since the previous inspection (photos 7 – 9).

Concrete apron undercut along left training wall (looking downstream)

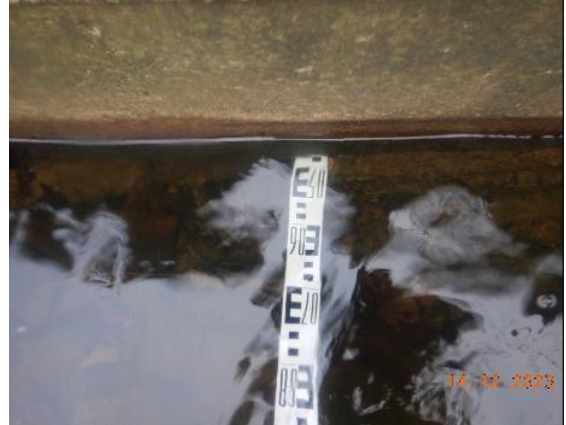
Photo 8

Concrete apron undercut along left training wall (looking downstream)

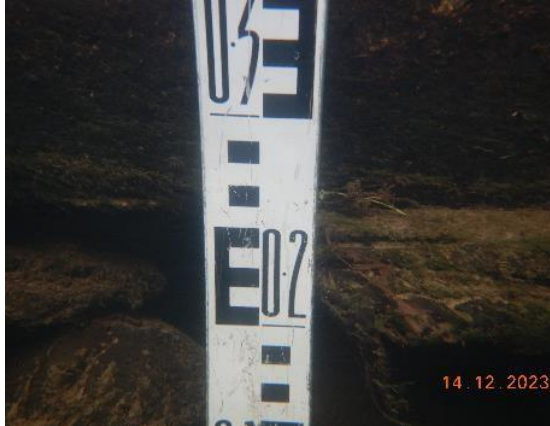
Photo 9

Concrete apron undercut along left training wall (looking downstream)

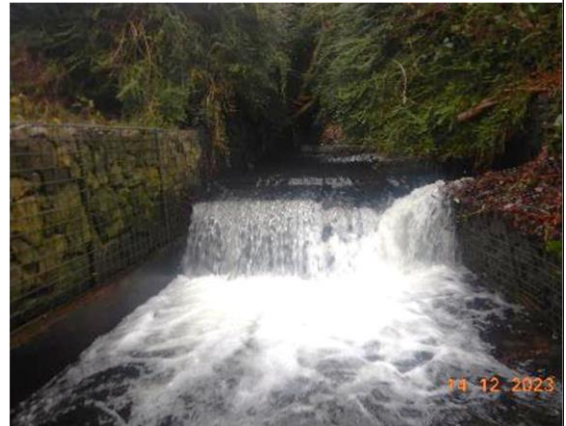
Photo 10

There was scouring and undercutting across the width of the weir upstream of the gabion baskets, measuring 2.5m wide, up to 0.5m high and up to 0.6m deep. Along the left side of the weir (facing downstream), the depth of the undercutting measured up to 1m (photo 10 – 13). However, owing to the turbidity of the water along the weir on the day of the latest inspection, it was not possible to obtain dimensions to determine whether the scouring and undercutting had deteriorated since the previous inspection.

Undercutting to weir upstream of gabion baskets

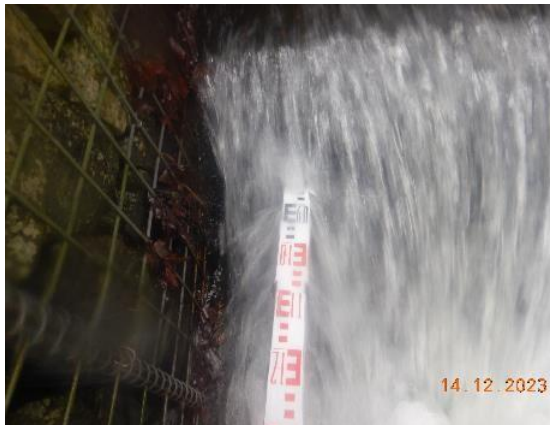
Photo 11

Undercutting to weir upstream of gabion baskets

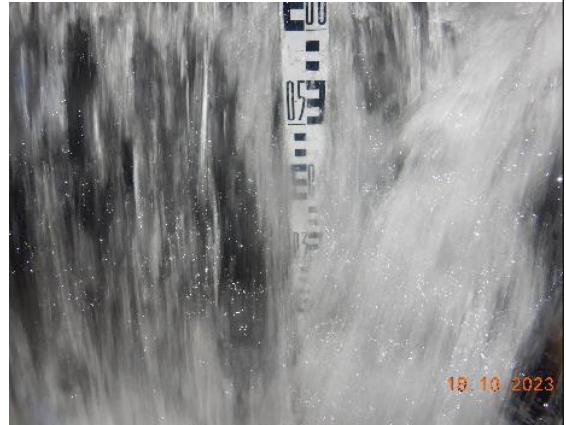
Photo 12

Undercutting to weir upstream of gabion baskets – photograph taken from October 2023 inspection

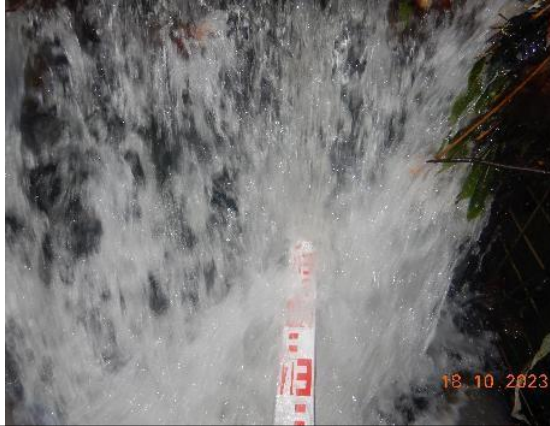
Photo 13

Undercutting to weir along upstream of gabion baskets – photograph taken from October 2023 inspection

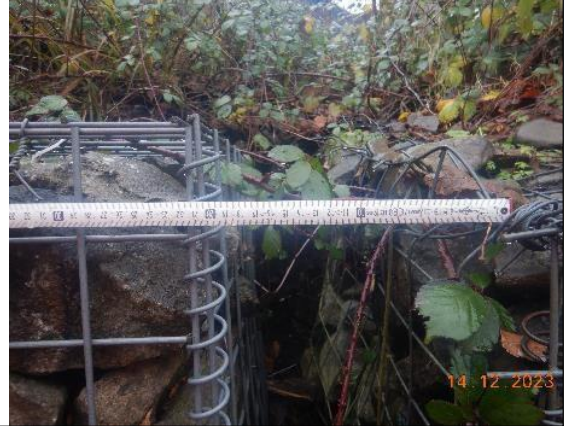
Photo 14

Misalignment of baskets along the left training wall (looking downstream)

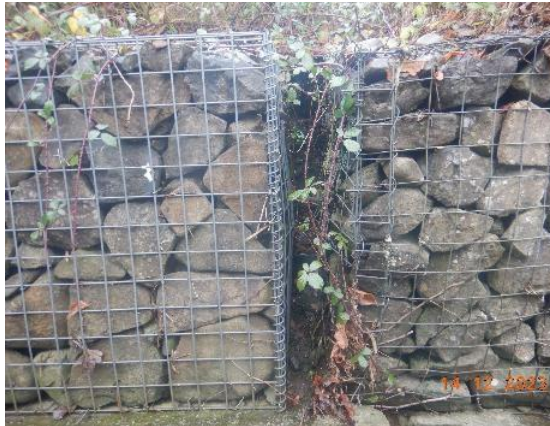
Photo 15

Gap between the baskets along the left training wall (looking downstream)

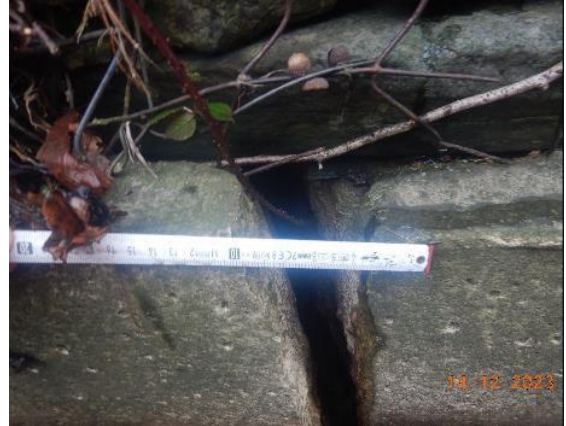
Photo 16

Misalignment of foundation along the left training wall (looking downstream)

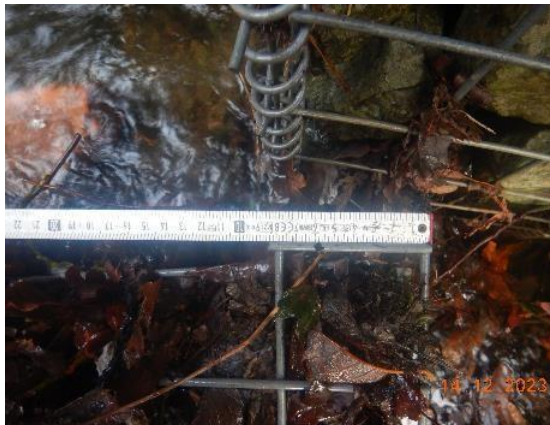
Photo 17

Measurement from the back of the upstream left gabion to the front of the adjacent basket

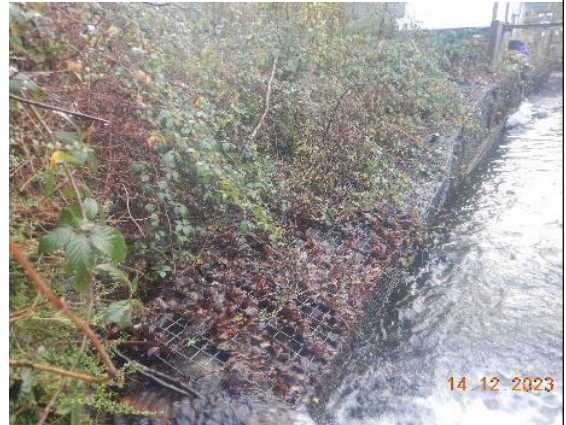
Photo 18

View behind the left gabion baskets from the top of the weir (looking downstream)
