Caerphilly County Borough Council
B425 I Gelligroes to Ynysddu
Road Safety Review and Road
Restraint System (RRS) Assessment
September 2023

B4251 Gelligroes to Ynysddu

Road Safety Review and Road Restraint System (RRS) Assessment

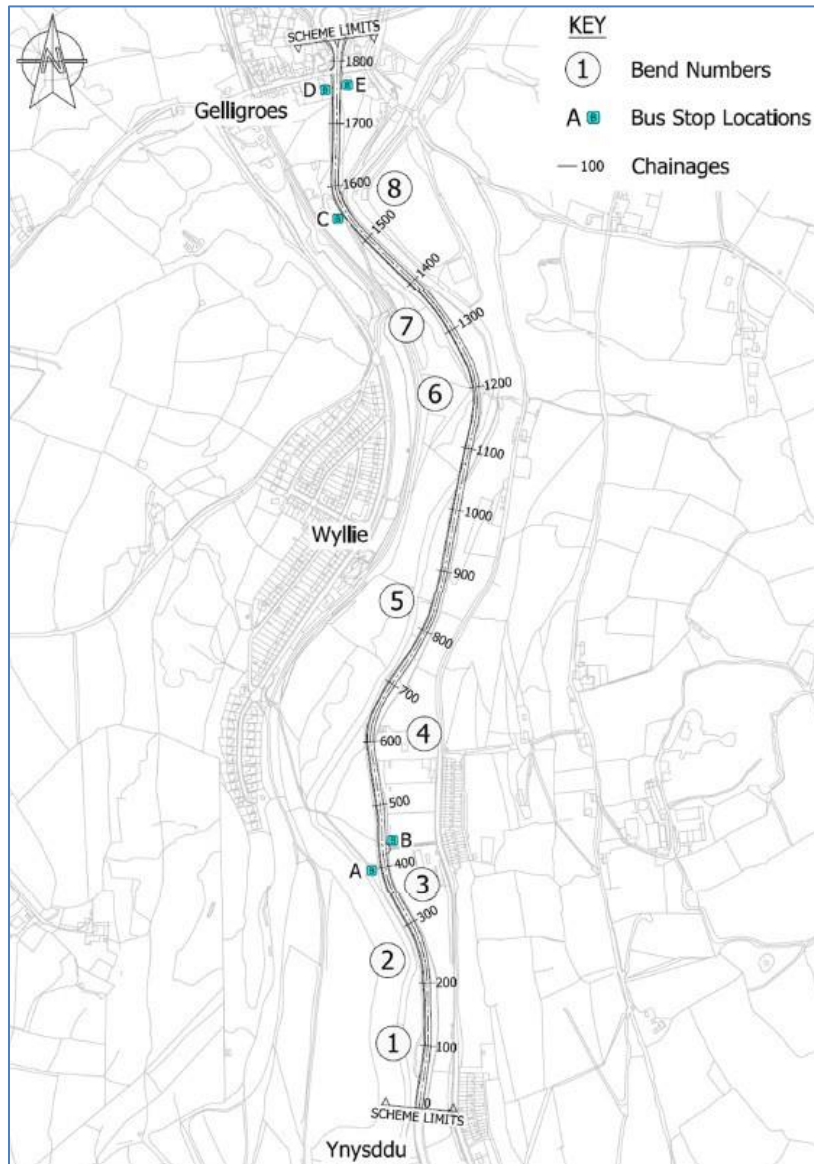
Figure 3: Bend Radii

3.4.3 The previous assessment with reference to Figure 9.23N2 ‘CD 109 Highway Link Design’ (Highways England, 2020) identified that “the radii should be 510-1020m for a 100kph road (100kph equates to a 60mph national speed limit for this classification of road)” (Amey Consulting, 2020). LTP would not necessarily agree with this as Figure 9.23N2 refers to design speed rather than the posted speed limit. Using Figure 2.1 of the same document, it is considered that the alignment and layout constraints on the route are more akin to a design speed of 85kph (53mph), rather than 100kph (62mph).

- 3.4.4 Regardless of the above, the previous assessment found that radii on all 8 bends fell well below the current standards for the 100kph speed which was used (see Table 11). In commenting on this, the report outlined that *“as the stretch of road within the study area is a well-established route, it is not expected to conform to current standards. Motorists are obligated to take the road as they find it, which means they should drive at an appropriate speed for the conditions. However, motorists may differ significantly in their interpretation of the conditions. This conflict has the potential to cause a hazard to all road users”* (Amey Consulting, 2020).

- 3.4.6 The final two columns of Table 11 identify radii requirements for speeds of 85kph (design speed of the route) and 70kph (actual speeds on the route). Aside from at bend 7, the achievable radii at all bends remains below the levels required at speeds of 85kph and 70kph. However, and as per the previous assessment, as a well-established route it is very unlikely that it would meet current DMRB standards. It is considered that the bend radii on the route, although below standards outlined within DMRB, are not significantly different from bends that can be found at other comparable locations in Caerphilly and across Wales. As previously outlined, it is also noted that the application of DMRB standards is not mandatory on roads such as the B4251. The previously discussed collision record also identifies improved road safety performance since the 40mph speed limit covered the full route. In addition, the speed data identifies that the 40mph speed limit appears to be successfully controlling vehicle speeds to around the level of the posted limit which should encourage more appropriate driving speeds at the bends.
