## CORPORATE HEALTH AND SAFETY COMMITTEE - 24TH FEBRUARY 2015

**SUBJECT: INTERIM REPORT - ASBESTOS IN SCHOOLS REMOVAL PROGRAMME**

**REPORT BY: ACTING DEPUTY CHIEF EXECUTIVE**

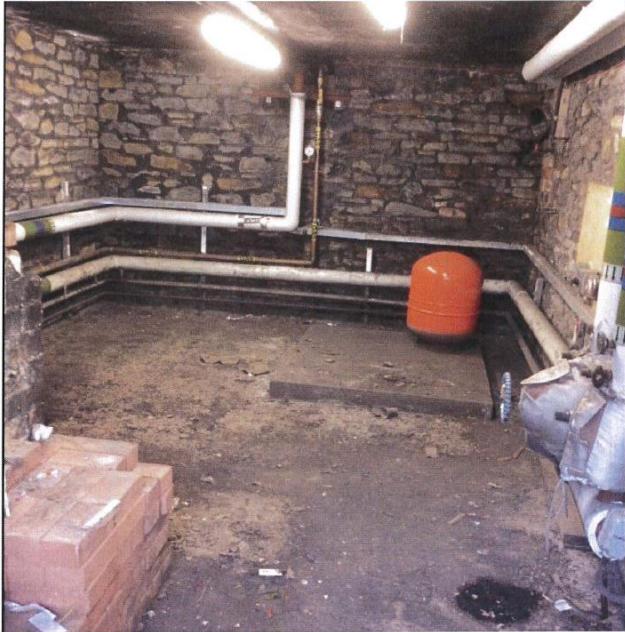
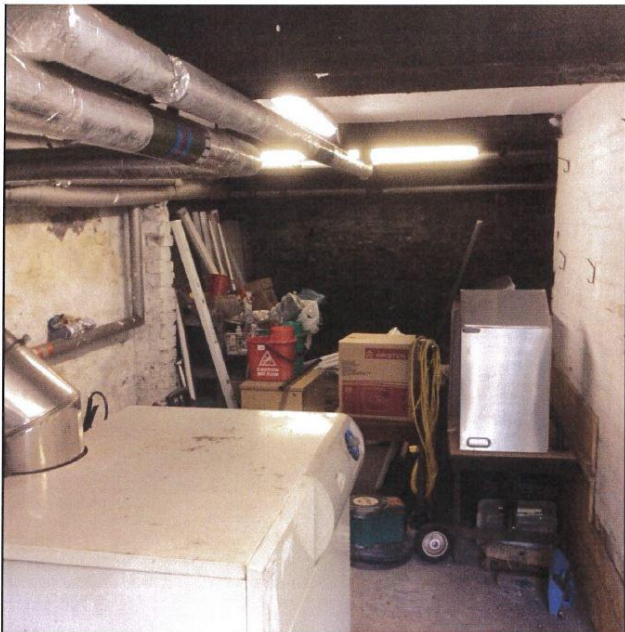
**Before**

5.5 The following photographs provide a visual account of areas of schools where work has already been completed; they show the condition of premises before and after the asbestos removal works.
