EDUCATION FOR LIFE SCRUTINY COMMITTEE – 24TH FEBRUARY 2015

SUBJECT: INTERIM REPORT - ASBESTOS IN SCHOOLS REMOVAL PROGRAMME

REPORT BY: ACTING DEPUTY CHIEF EXECUTIVE

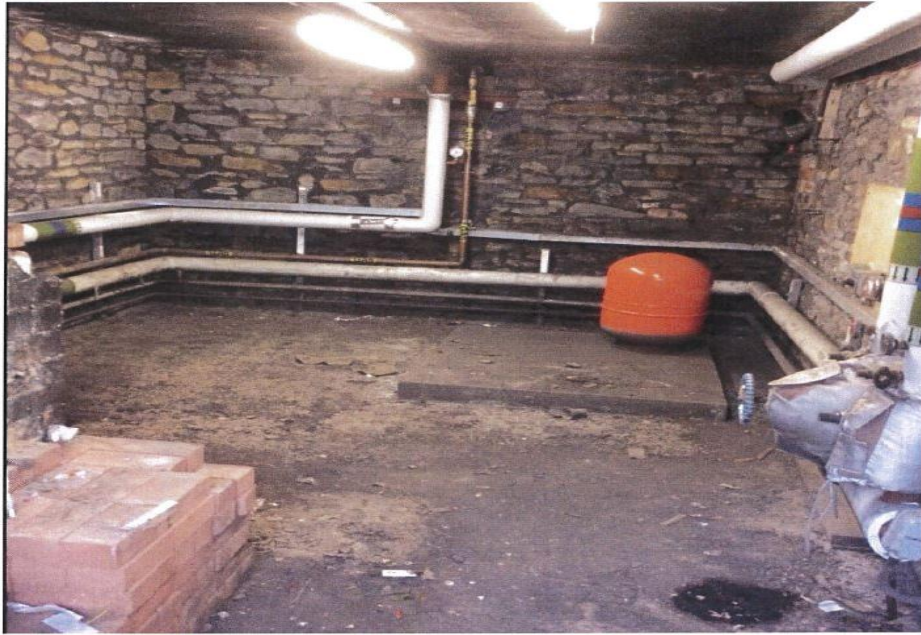
Before

5.5 The following photographs provide a visual account of areas of schools where work has already been completed; they show the condition of premises before and after the asbestos removal works.
