**Environment Agency Wales**  
**Non-Technical Summary**  
**Pollution issues affecting the Nant Caeach, Nelson**

**Mair Davies**  
**Environment Officer**  
**February 2011**

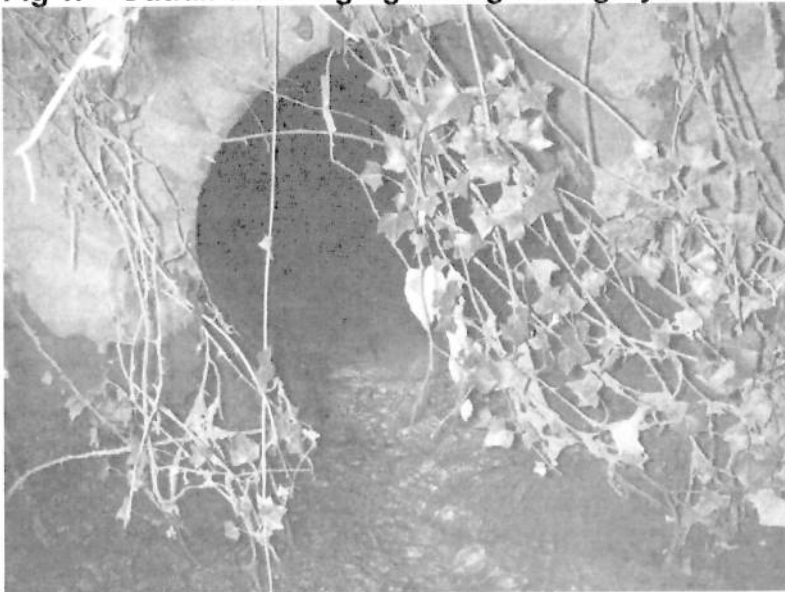
**Fig 1. – Outfall discharging sewage-like grey water**

The same locations were sampled in September 2010, with the aim of establishing whether there had been any improvement in the biological status of the watercourse since the slurry incident, and to try and locate where the other pollutions were entering the Nant Caeach. The biological quality status of the small un-named tributary generally remained poor, however it had slightly improved since the 2009 survey, indicating that there had been some recovery. Two areas were identified where sewage-like discharges were entering the Nant Caeach, and further investigative works are still currently ongoing to locate the sources. It is likely that they are the result of misconnected drains from properties within the Nelson area. It was also found

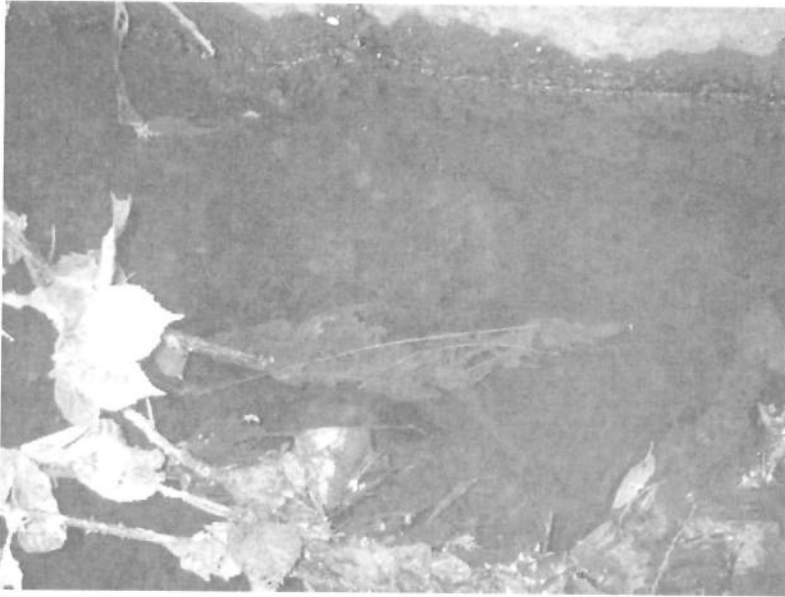
**Fig 2. – Sewage fungus seen downstream of Outfall**

The results from the August 2009 survey showed that the biological status of the small tributary and the Nant Caeach was poor, with widespread sewage fungus present. There was evidence to show that the macro-invertebrate community had already been degraded by long term, chronic, pollution, before the acute pollution from the slurry spill occurred.

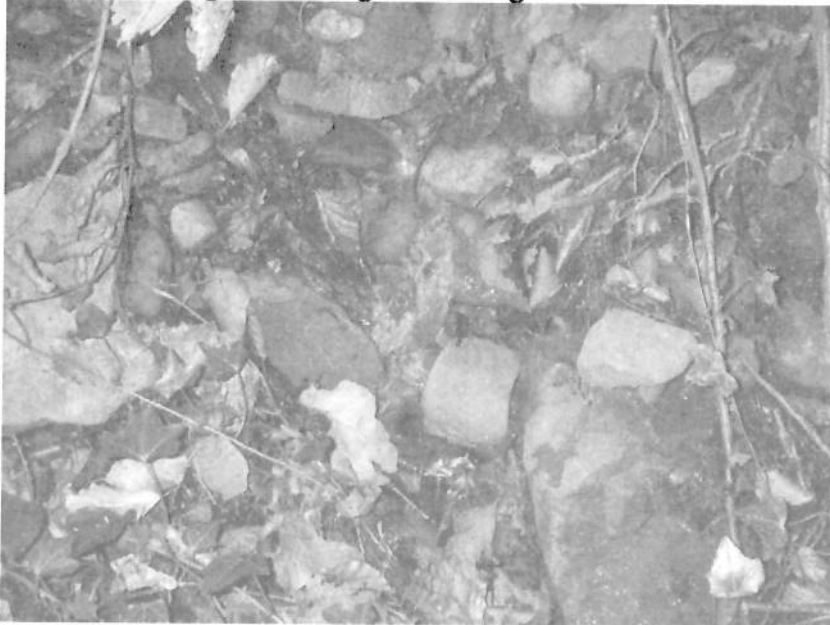
**Fig 3. – Sewage discharge leaching from river bank.**
