Caerphilly County Borough Council

**Bute Town (Drenewydd)
Conservation Area
Character Appraisal**

July 2013

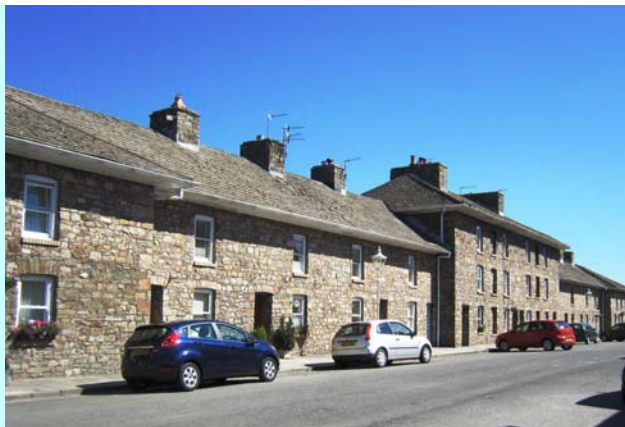
Model village comprising terraced housing: Collins Row, Middle Row and Lower Row.

- Excellent example of amongst the earliest planned industrial housing
- Three rows of terraced housing constructed specially for Ironworkers in the Rhymney Valley.
- Designed to be a strong, balanced, unified and formal architectural composition using Renaissance 'Palladian' Principles.
- Uncommon form of architecture for this era – built with good space and light.
- Largely unchanged from its original construction.
- Dominant, hipped roofs and deep overhanging eaves.

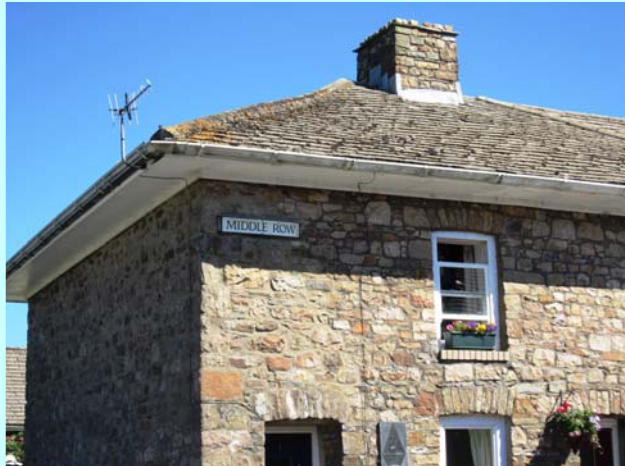
Shallow, hipped roofs, deep overhanging eaves and sliding sash windows

- Deep overhanging eaves provides a distinct roof edge.
- Consistent and symmetrical along the three individual rows.
- Most roofs have a shallow pitch of 30° - allowing for the middle 'link' roof blocks of 40° to appear more prominent without changing the eaves or ridge height.
- Doors and windows of vertical proportion are recessed within the stonework. They are one over one sliding horned sashes and of a symmetrical pattern throughout.

7.7 The shallow hipped roofs, deep overhanging eaves and sliding sash windows are all unique to the design of Bute Town. Roofs were covered with locally quarried sandstone tiles, pegged over battens, and the roof structure comprised wrought-iron strapped and bolted king-post trusses with cut purlins and rafters. Although roofs had deeply overhanging boarded eaves, they were without rainwater goods.

7.8 Windows originally had cast-iron frames with thin glazing bars in a 3 over 6 arrangement with small top-hung casements. Windowsills were probably locally quarried sandstone, later replaced with buff brick, and doors were ledged, braced, boarded and painted.

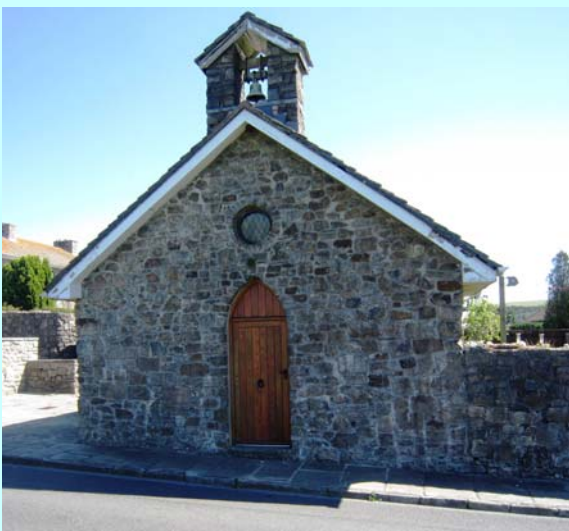
St Aidan's Church

- Originally a stable block built alongside the houses in 1835.
- Situated in a prominent position to the west of Bute Town and clearly visible from the main road.
- First established as a Church in Wales in 1890 and renovated in 1979/80.
- Still a key part of the community - a quaint church with bell-tower used for regular church services, as a polling station, and for presentations and meetings.

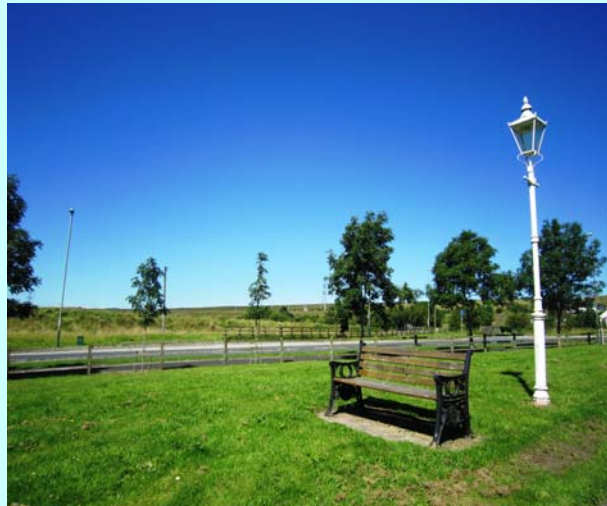
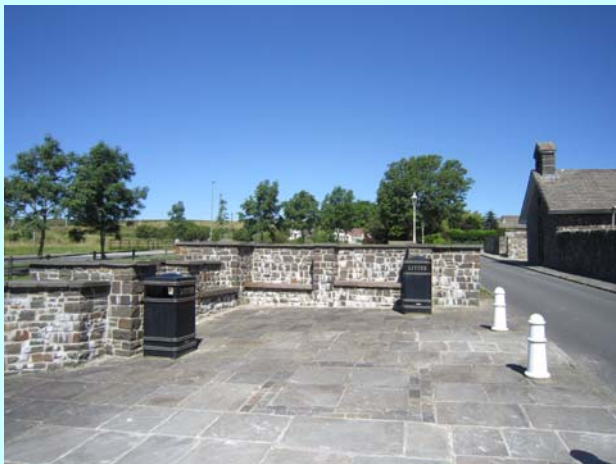
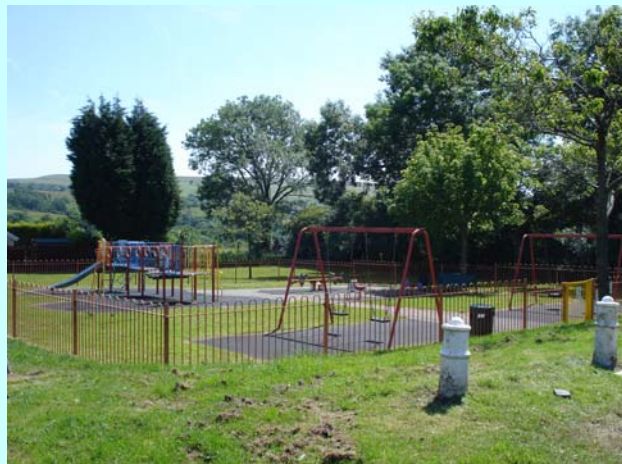
- Areas of public open space are present within the Conservation Area – especially around the west where the old railway line has been dismantled and landscaped.
- These areas are well maintained and provide an open place for residents to relax.
- These spaces help preserve the open aspect of the Bute Town village, and its environs.
- Wide streets help to maintain the open aspect of Bute Town.
- The children's play facilities are well located and equipped.

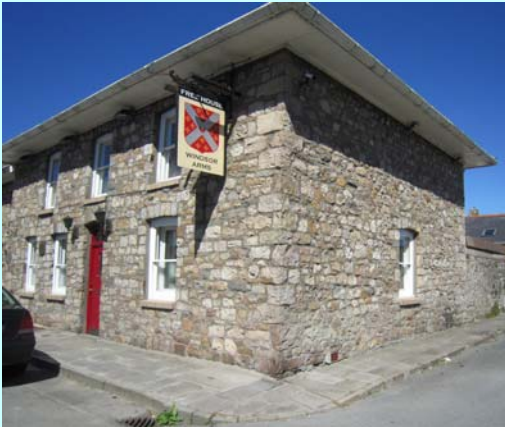
The Windsor Arms Public House

- This grade II listed building provides an historic link to the industrial era, as it was and is the focal point for socializing and a venue for meetings.
- Maintained as a public house since 1841 through to the present day.
- The pub shares Bute Town's traditional stone frontages, with 2-pane horned sliding sash windows and deep, overhanging eaves and front door as found in the village, painted timber-boarded with a central obscured glazing aperture.
- Traditional pub signage

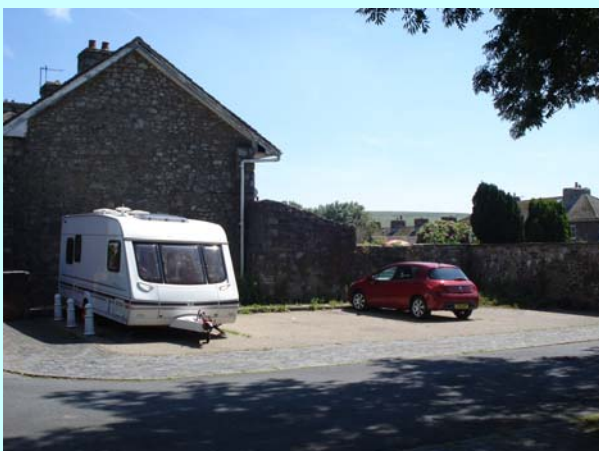
Formalisation of parking arrangements

- Three parking areas are located on the site of the former dwellings at 15 and 16 Collins Row, at the end of Middle Row facing the recreation area and at the approach way into Butetown.
- They allow for a structured approach to parking in an area where parking is difficult.
- Sensitively designed and structured.

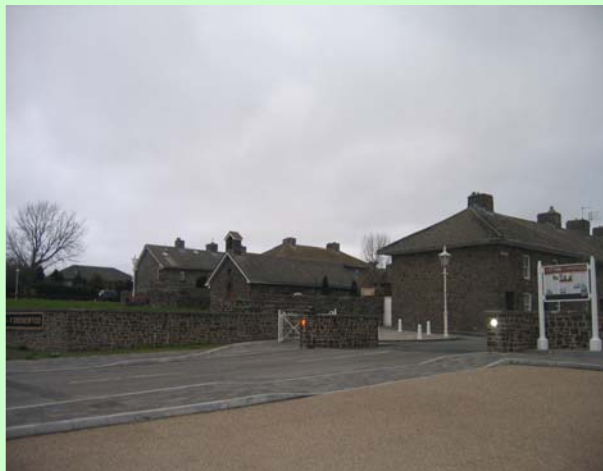
Defective roof coverings and roof space conversions

- The existing roofs are in a poor condition and are all defective. They comprise of reconstituted stone tiles with matching ridges that have exceeded their life expectancy.
- Some chimney stacks have not been re-built; the flaunching is in a poor condition and the lead work poor.
- A variety of rooflights have emerged to create attic spaces, some of which are deteriorating.

7.12 The existing roof coverings are pitched, hipped and finished with reconstituted 'stone' tiles laid in regular courses with varying widths. The ridge is similarly finished with a reconstituted 'stone' tile of regular width, cemented in place. The roofs are in a poor condition generally, and have now exceeded their design life. Consequently, they are brittle, fractured, slipped and missing in many areas. It is apparent that the tiles have significantly weathered in many locations. The weathering is uneven, has created hollows on individual tiles where water can sit. This has attracted excessive moss growth on north facing roofs that holds in the moisture, looks unsightly as well as significantly increasing the loads on the roof.

have no pots or capping showing a square flue opening. The leadwork is often defective and the flaunching is in a poor condition. Some stacks have been rebuilt, whilst it is clear that those with randomly coursed stonework have not.

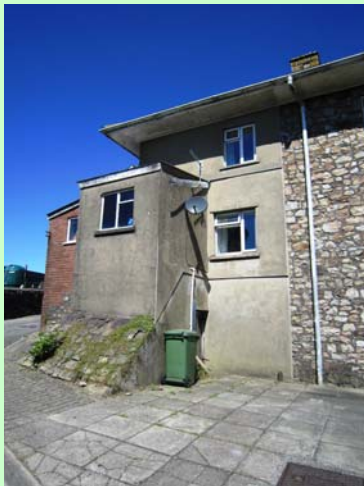
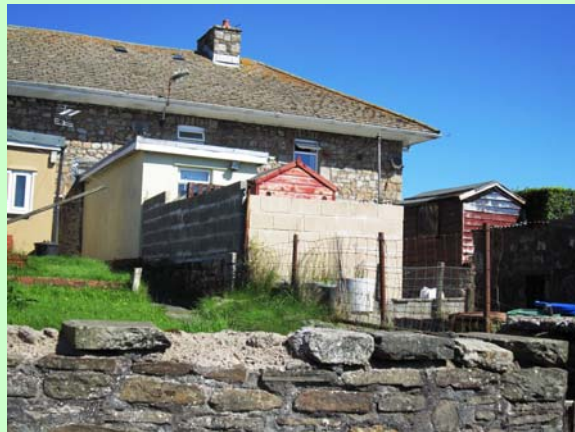
- Many properties have developed single storey rear extensions to accommodate additional modern facilities – for example, kitchens and bathrooms.
- Some rear windows have been replaced with white UPVC.

- The rear lanes contain a mix of rear walls, extensions and garages which serve to fragment the appearance of the area through the use of inappropriate materials, sizes, colours and finishes.

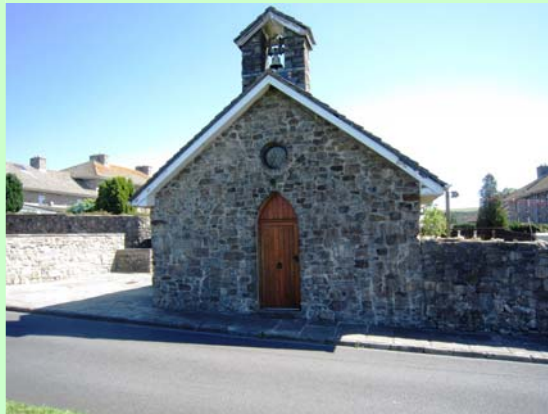
St. Aidan's Church

- This is currently a prominent; 'hard' landscape area to the north of the church that is covered with uneven concrete slabs (to replace stolen pennant slabs).
- These could perhaps be benefit from being replaced with a 'softer' rose garden and seated area, which would contribute positively, to local community life.
- A combination of Welsh Church Fund or C in W funding may be available for this.

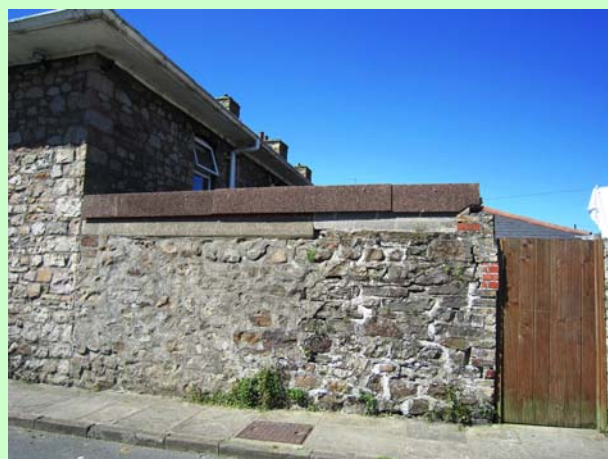
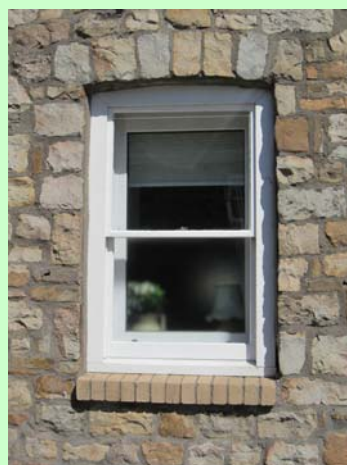
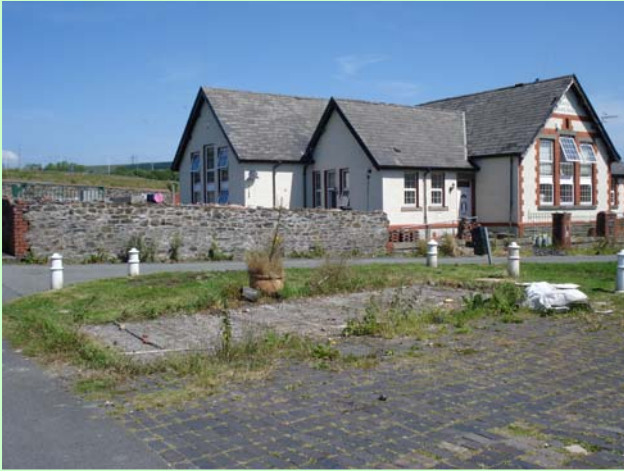
Windsor Arms Public House

- Unsympathetic repair work undertaken on some boundary walls.
 - Use of inappropriate materials such as red brick, render and alternative rubble stones.
 - Walls have been pointed in lime based and cement based mortars using a variety of pointing styles.
 - A small bulge is visible in the gable end to the Windsor Arms pub.
-
- Visually intrusive secondary glazing has been installed behind single glazed sliding sash windows, detracting from the historic fabric and character of the building.

- On land opposite the public house there is a paved area for car parking that leads onto the children's play area that could be landscaped and tidied up.
- There may also be potential to provide a formal seating area here in association with the Windsor Arms PH.

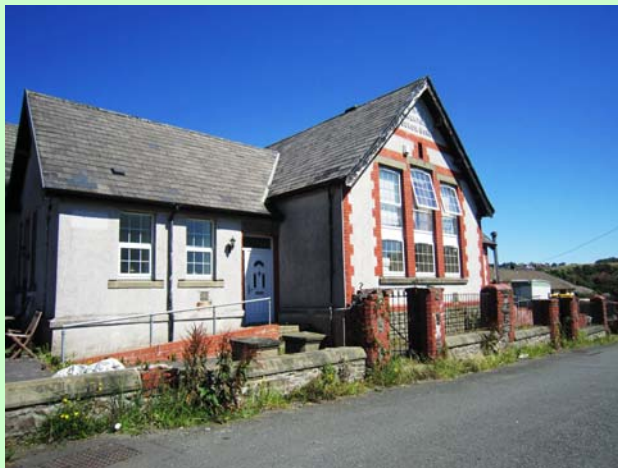
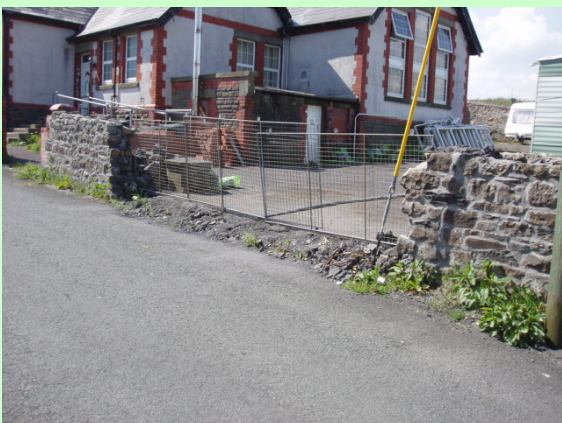
Former Drenewydd Primary School and Community Centre – now 'Drenewydd House'

- UPVC windows and doors were installed as part of recent conversion works to the former school, damaging the architectural character of the building.
- Caravans have been sited within the curtilage of the former school.

- Part of the pennant sandstone boundary wall has been demolished.
- Cumulatively, these changes have a vastly detrimental impact on the character and appearance of the Conservation Area.

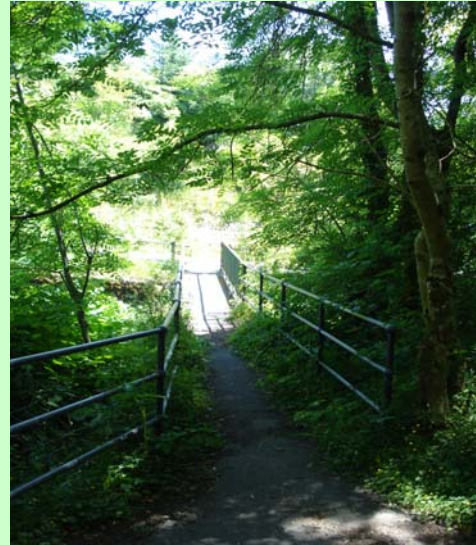
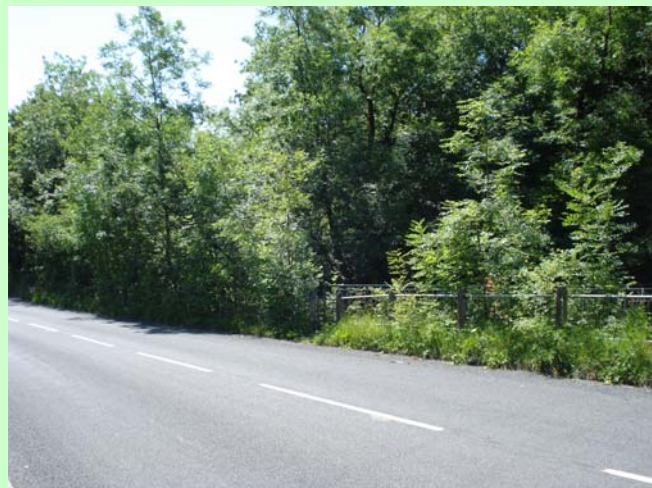
Footpath linking Bute Town with the B4257, the Old Furnace Farmhouse, Rhymney House & the Union ironworks Site.

- The footway down to the Rhymney River is narrow and in parts overgrown with trees and bushes.
- There is a river crossing although this needs some attention and could be subject to an enhancement scheme in liaison with Highway engineers and Countryside Services.

- The bridge takes a pedestrian straight onto the main road, without realising it and traffic can take you unawares. There needs to be a provision for improving the walker's awareness of this.
- There is no discreet, unobtrusive signage indicating where you are or directing you to the scheduled ancient monument just to the south.

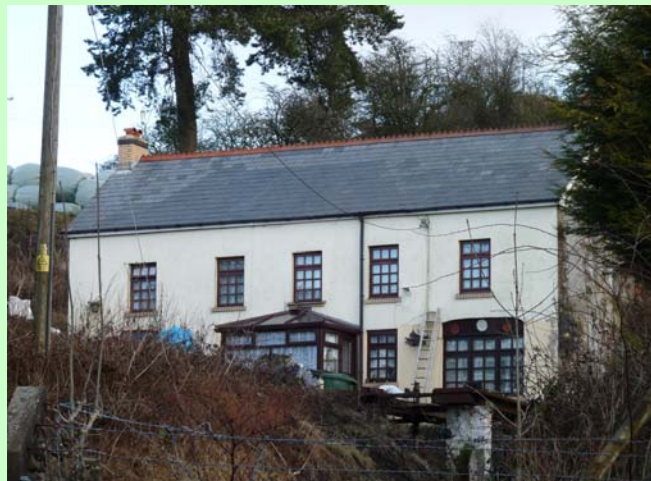
Old Furnace Farmhouse, Llechryd, Rhymney

- A grade II listed building, retained on Cadw's list notwithstanding extensive, unsympathetic alterations including new windows.
- Important for its early cast iron roof structure although no longer visible and as a scarce survivor of early ironworkers' housing.

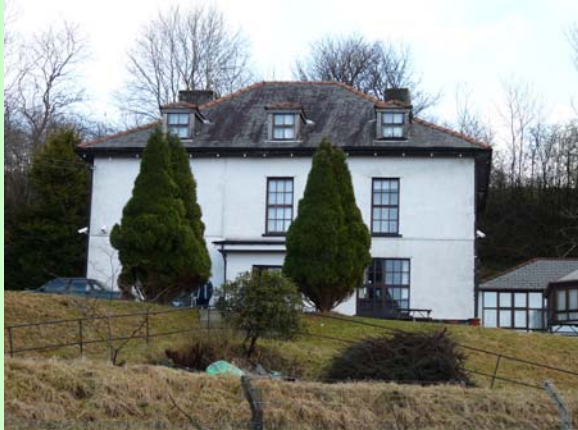
Rhymney House Hotel, Llechryd, Rhymney

- A grade II listed building, retained on Cadw's list, notwithstanding substantial external and internal alterations for its key position on the site of the earliest ironworks in Rhymney and its important connections, being built in 1801 as the Manager's House of the Rhymney iron Company.
- Large detached house formerly with 12 pane and tripartite sashes now replaced.
- Reputed to have retained a cast iron roof structure although no longer visible.

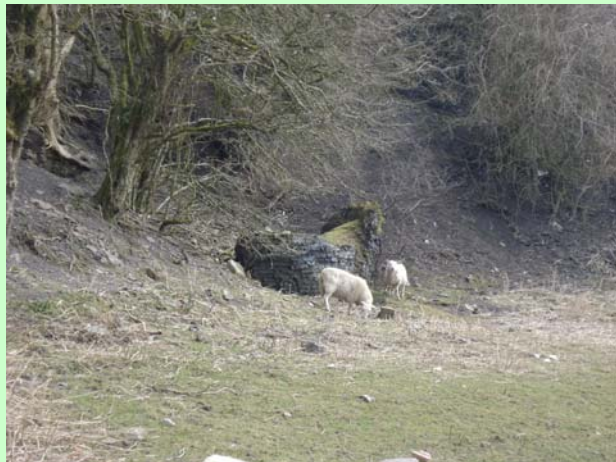
- This field is in private ownership, is protected by an established, well-laid hedge with post & wire fencing behind, and is currently used for grazing sheep. It would go unnoticed if it weren't for the fact that at the core of this site are visible remains and features of an early ironworks site, a hugely important scheduled ancient monument with huge potential in the context of SE Wales Industrial Ironworks landscapes.
- The scheduled area lies at the foot of a steep west-facing slope. Remains of a first generation single coke fired and water blown blast furnace is thought to remain there, although only the circular hearth and bowl are now visible.
