Caerphilly County
Borough Council

BUILDINGS AT RISK STRATEGY 2023 - 2028

Buildings at Risk Strategy 2023 - 2028

October 2023

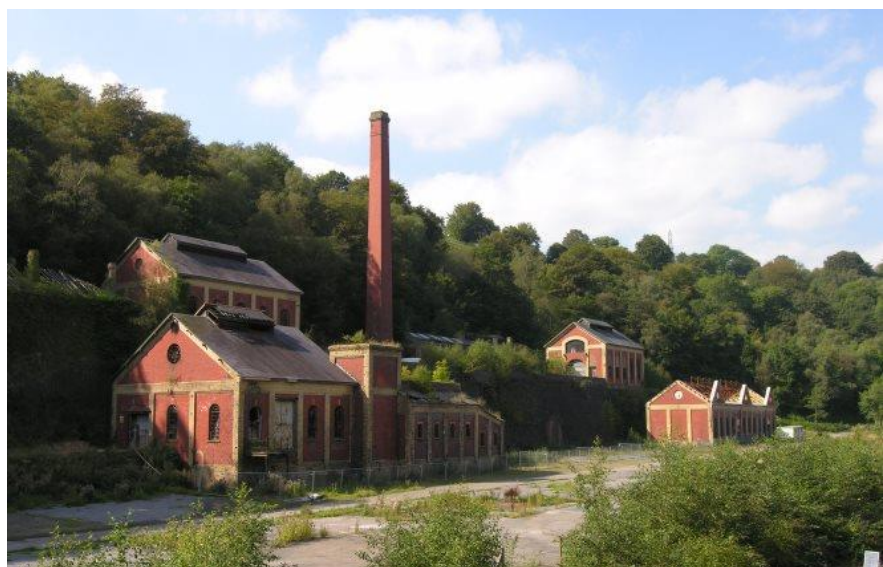
Navigation Colliery, Crumlin

An almost complete model colliery from the early 20th century.

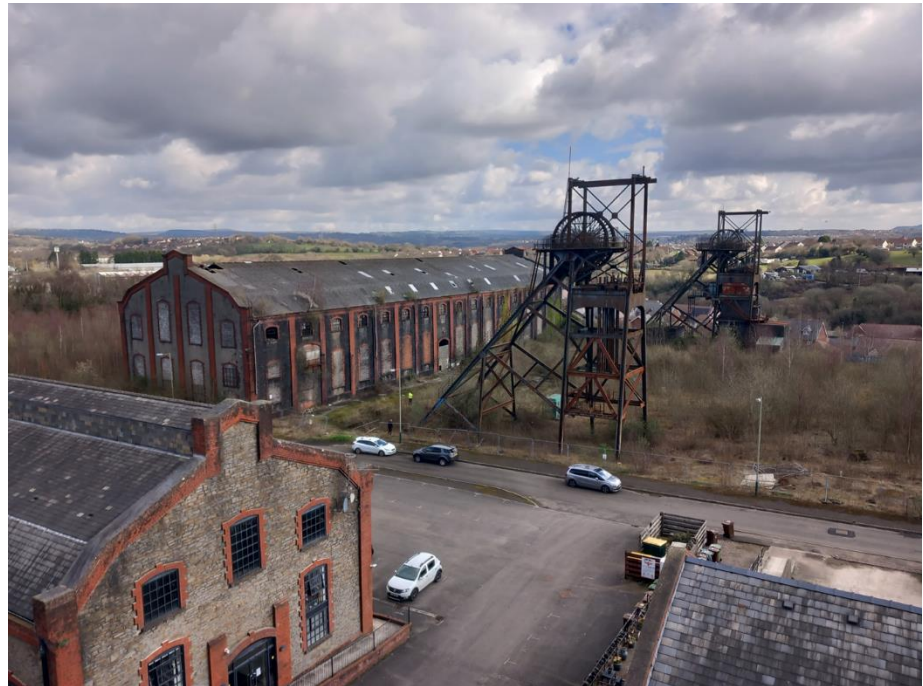
Penallta Colliery

The massive powerhall of the former colliery has permission for conversion but this has not yet been implemented

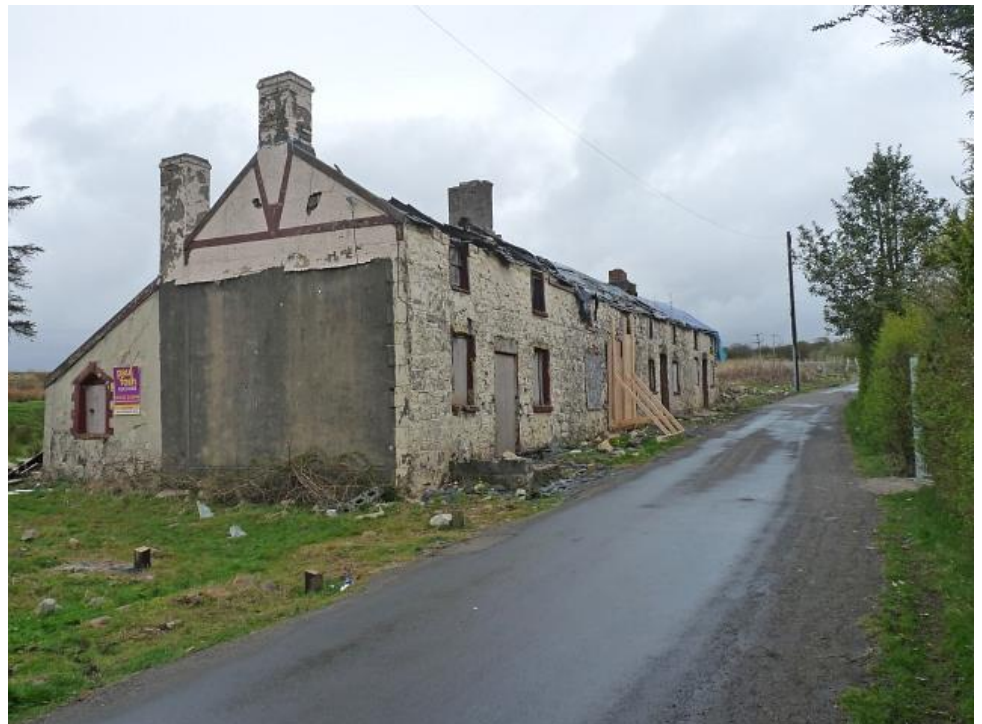
*Susannah Houses,
Rhydney*

A restoration scheme has been agreed with the buildings owner but has not yet been fully implemented.

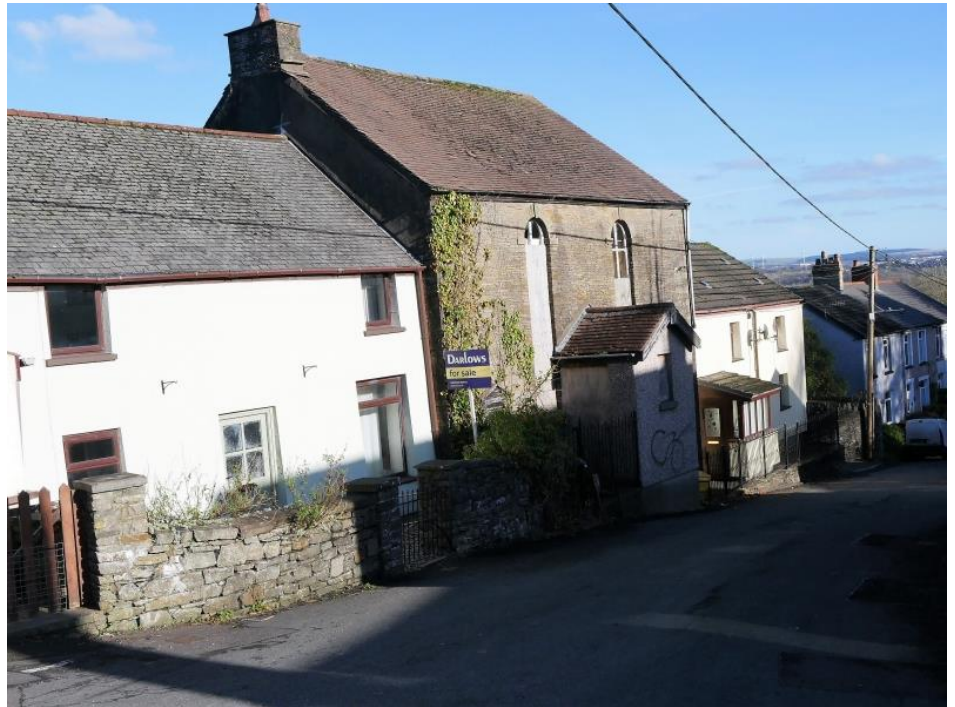
*Horeb Baptist Church,
Gelligaer*

*The conversion and extension
of the chapel to form a house
has been approved and is
being implemented.*

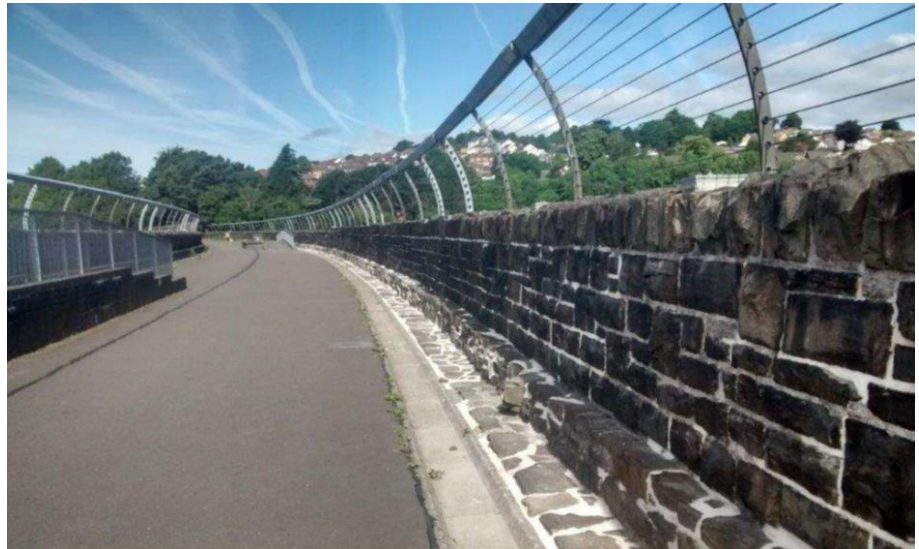
The refurbishment of the Grade II* listed Maesycwmmmer / Hengoed Viaduct and its opening up to pedestrians and cyclists as part of the National Cycle Route (Route 47) after it had been closed for over 35 years, with the installation of new fencing and integral lighting, easy access viewing platforms and sculptures; has given this structure a new lease of life.

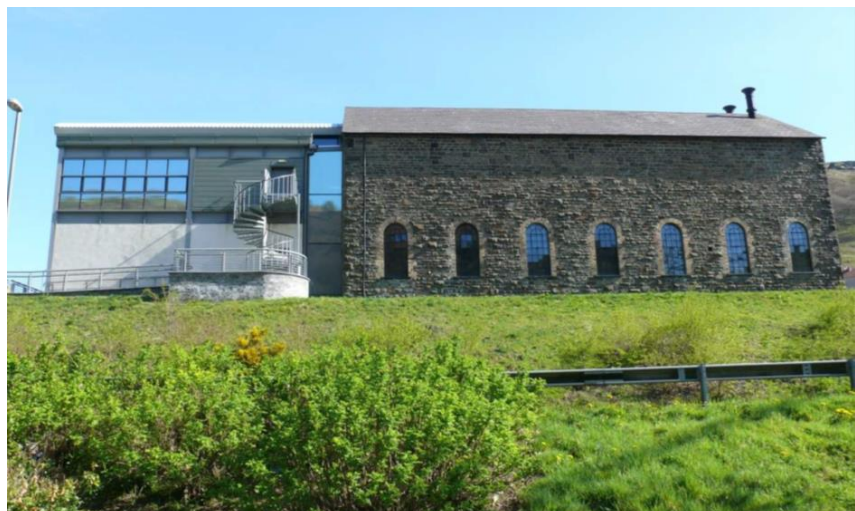
The Winding House, New Tredegar is a grade II* listed building, built on the site of the former Elliot Colliery; the museum's centre-piece is its original Victorian winding engine, that used to operate the cages that transported men and coal between the surface and the mine below. It has been sensitively refurbished and extended to provide a museum, Heritage Research Centre and coffee/gift shop, and is run by local volunteers.

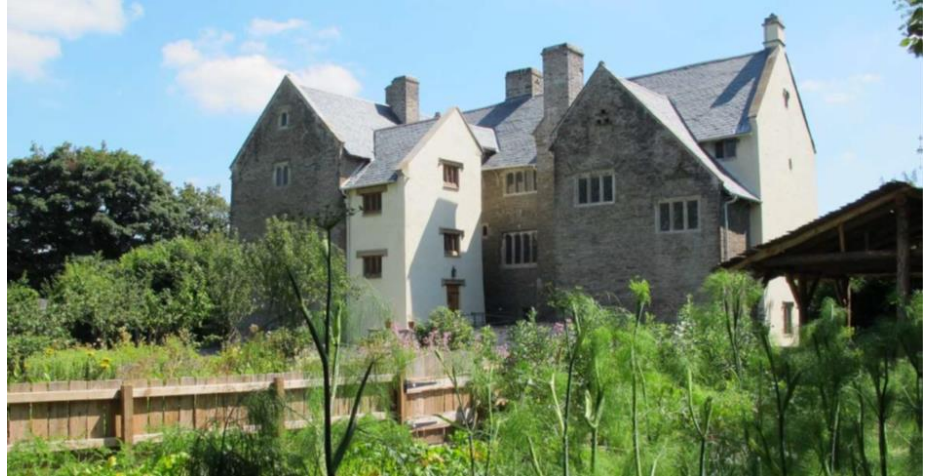
Llancaiach Fawr Manor House, a grade I listed manor house, has been sympathetically restored inside and out, with the important addition of a new accessible lift and staircase tower hidden discreetly to the rear, to provide greater access to this major visitor attraction, designed in close consultation with Cadw and in line with the provisions of the Equality Act 2010. It was built for Dafydd ap Richard in C1550.

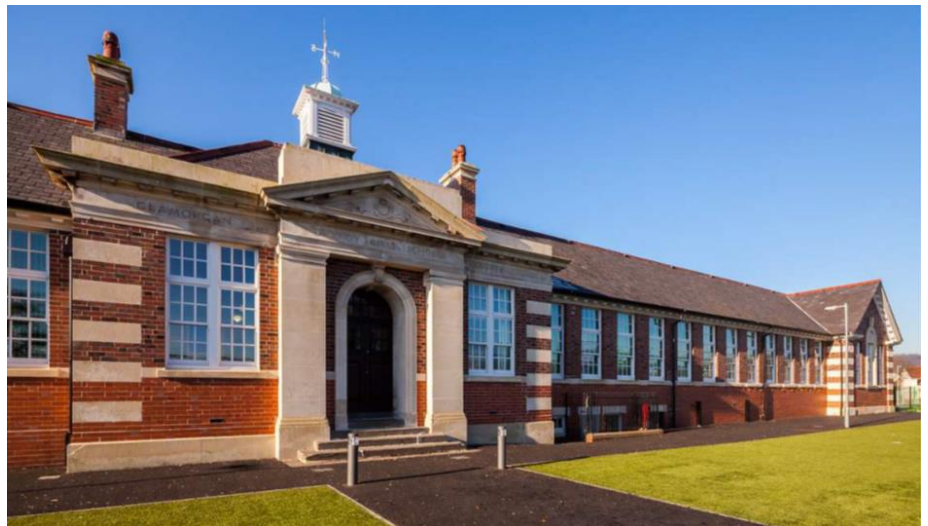
St Ilan's School

The bringing back into full educational use of the former St Ilan's school, Pontygwindy Road, Caerphilly which stood vacant and deteriorating for over 7 years, is now a Welsh medium primary school and now stands proudly fronting a large super-school site, now known as Ysgol Gyfun Cwm Rhymni Y Gwyndy Campus.

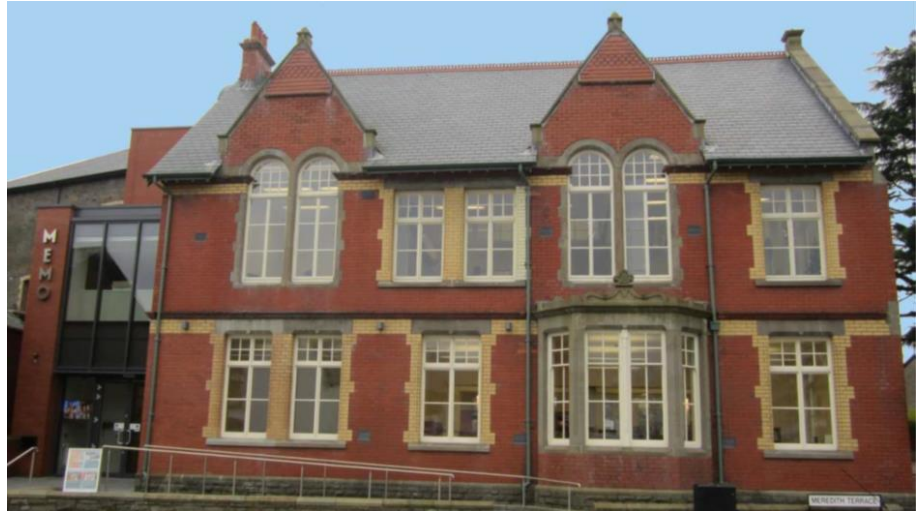
Newbridge Memo

The Celynen Collieries Workmens' Hall (Memo of 1924) and Workmens' Institute (of 1908), High Street, Newbridge, 2 fine grade II* & II listed buildings, have now both been brought back into public use as a thriving arts and entertainment centre, serving the valley communities of SE Wales, with a public library, theatre conference venue and ballroom.

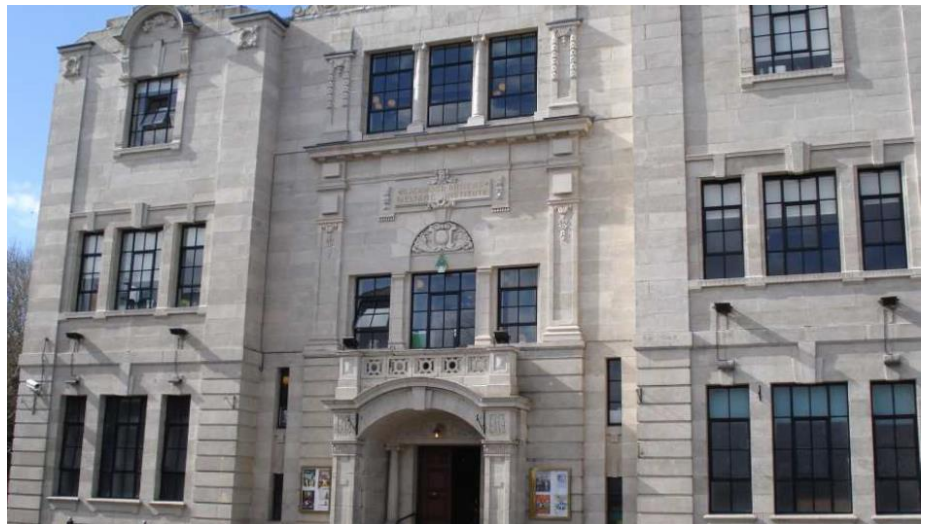
Blackwood Miners Institute

Blackwood Miners' Welfare Institute, High Street, Blackwood, a fine grade II* listed building that first opened its doors in 1927, has been sensitively refurbished throughout and a new, rear extension has been built to provide spacious performance facilities.

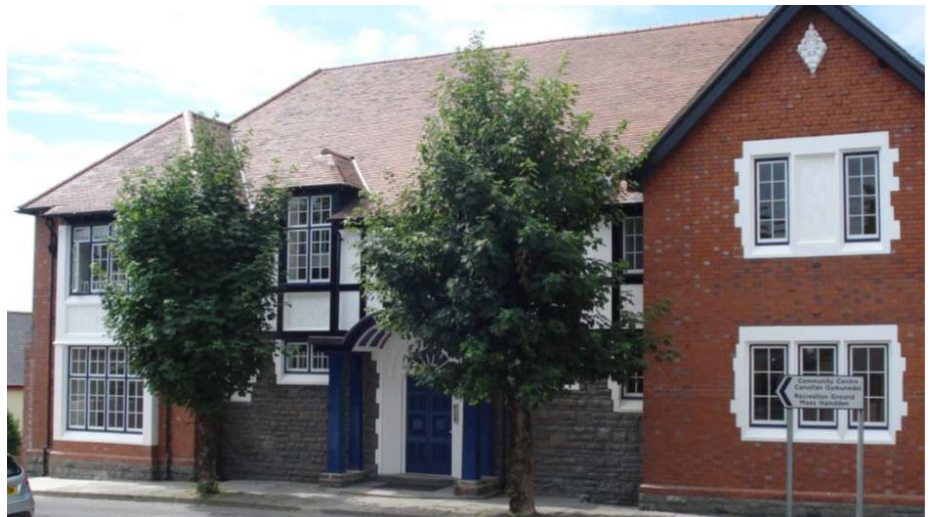
Oakdale Public House

The former Oakdale Hotel, Oakdale, which was for many years a deteriorating redundant public house and grade II listed building, has been sensitively converted into 9 residential apartments achieved through collaboration with the Welsh Government, Pobl, Caerphilly's Private Housing Section and its Planning Section.
