Caerphilly County Borough Council
B425 I Gelligroes to Ynysddu
Road Safety Review and Road
Restraint System (RRS) Assessment

September 2023

**Road Safety Review and Road
Restraint System (RRS) Assessment**

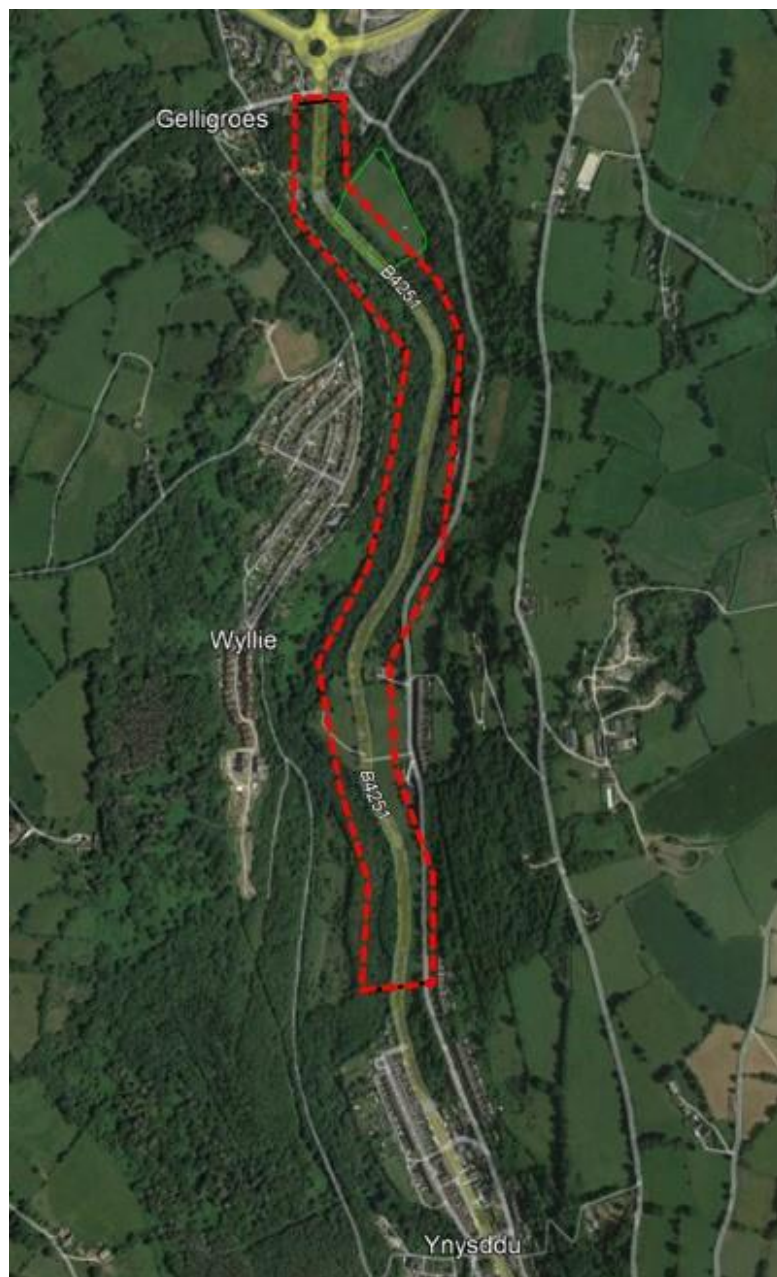
Figure 1: Study Route

- 1.1.1 Local Transport Projects Ltd (LTP) has been commissioned by Caerphilly County Borough Council (CCBC) to undertake a Road Safety Review and Road Restraint System (RRS) Assessment for the approximate 1.8km length of the B4251 between Gelligroes and Ynysddu. As identified within Figure 1, the study area extends from south of Heolddu Road in Gelligroes to the village boundary in Ynysddu. Gelligroes roundabout, which is located a short distance north of Heolddu Road, is not included within the study area.

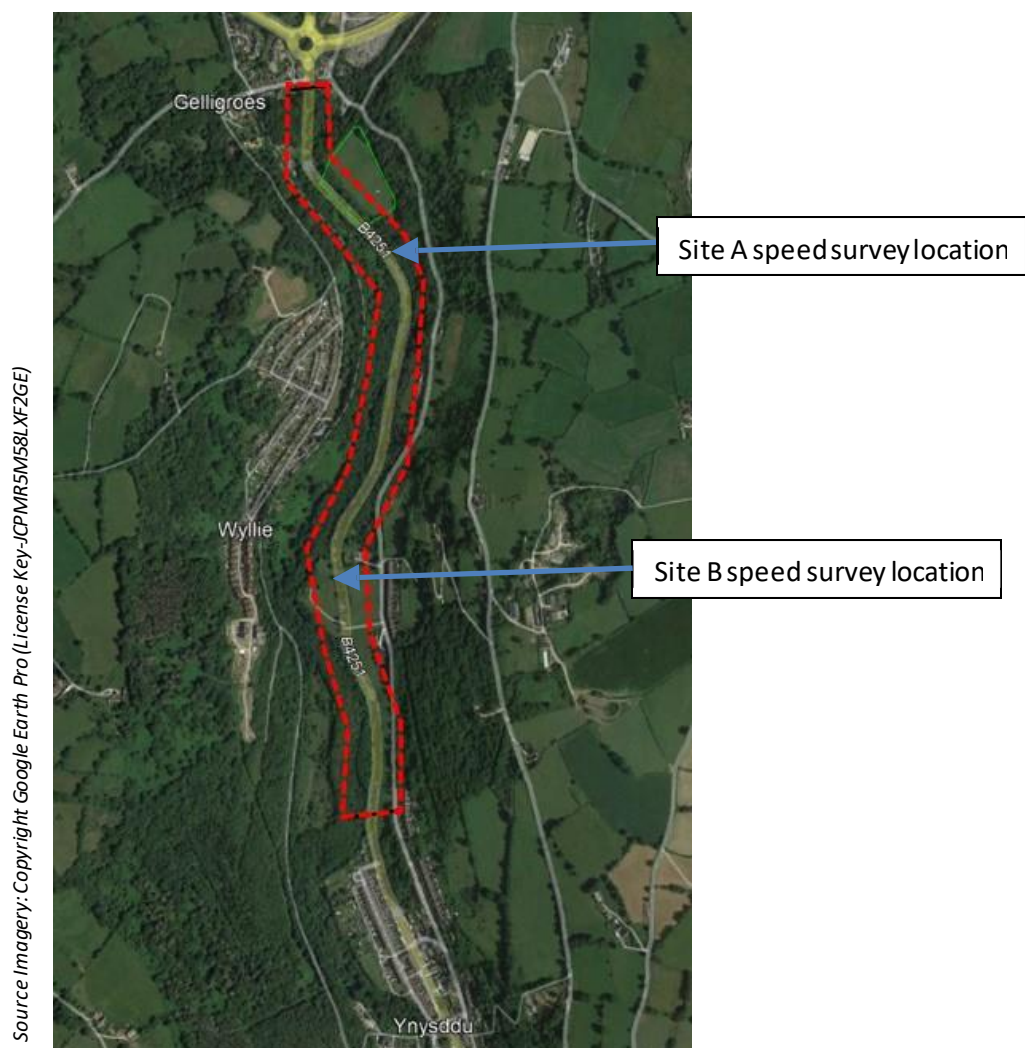
Figure 2: B4251 Speed Survey Locations

2.2.2 The above speed survey locations are identified within Figure 2 and the survey results summarised within Table 1. The complete ATC data is included as Appendix 1.

Survey Location	Posted Speed Limit	Mean Speed			85 th %ile Speed		
		Northbound	Southbound	Two-way	Northbound	Southbound	Two-way
A	40mph	39.3mph	41.7mph	41mph	43.6mph	46.6mph	45mph
B	40mph	37 mph	41.8mph	39mph	40.7mph	46.4mph	44mph
