APPENDIX 4 Sewerage Briefing Paper (Sent to Members on 26TH February 2021)

Historic Flooding and Sewerage Issues at the Sue Noake ATP

Manhole surcharge at the site of the proposed new pitch SN2

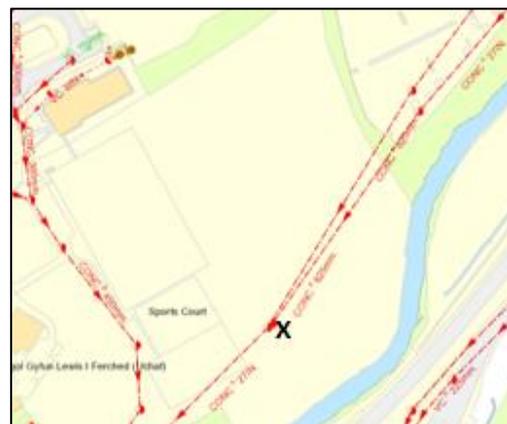
Two manholes (located alongside **X** in the diagram below) sit above a mainline or trunk sewer and are the responsibility of Welsh Water.

Welsh Water have confirmed that their own records indicate that there have only been two recorded incidents of the manholes shown at **X** surcharging over the previous ten years. The first of these was in 2014 and the second, the most recent incident, in January 2021. Discussions with Welsh Water this week confirm this to still be the case.

When a breach of this nature occurs, particularly on a trunk sewer, Welsh Water have a number of specific responsibilities. These can be summarised as site containment, decontamination, reinstating the manholes, investigation and remediation.

With regard to the breach at Sue Noake, the area of the surcharge has been cordoned off by Welsh Water (site containment) to enable the elements to begin naturally breaking down any waste material (decontamination). The manholes have also been reinstated.

Welsh Water have begun a detailed investigation of the breach and will return to site this week to continue to explore both upstream and downstream using specialist camera equipment. This will enable Welsh Water to identify the cause and prescribe the necessary remedial action to clear the system and protect against future breaches.

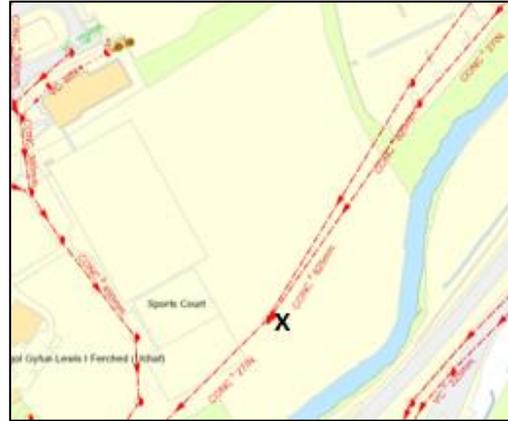
The likelihood of a reoccurrence of the recent surcharge of the manholes at **X** is considered unlikely and the frequency of reports over the last decade would appear to support this position.

The Council will make an application to Welsh Water to relocate the manholes further away from the pitch.

In the interim the Council is also exploring as part of its plans for SN2 the possibility of developing a protective 'bund' around the manholes. A 'bund', essentially, a raised grass bank will be installed between the pitch and the manholes to provide additional protections to the new pitch from any debris that may emerge should the manholes surcharge again at a future point.
