## APPENDIX 4 Sewerage Briefing Paper (Sent to Members on 26<sup>TH</sup> February 2021)

### Historic Flooding and Sewerage Issues at the Sue Noake ATP

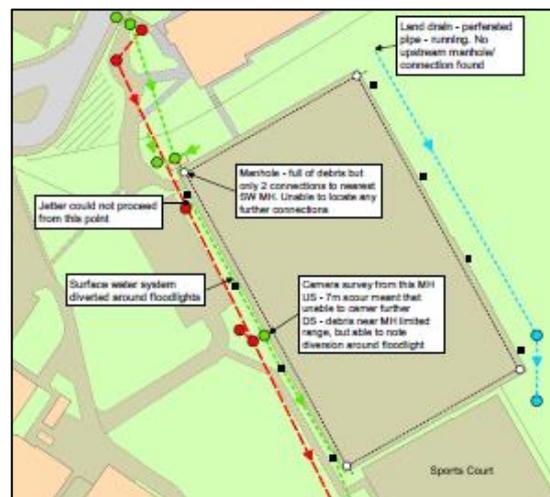
The first was a collapsed storm drain that runs the length of the ATP (see green dots in Diagram ---).

The second was traced back to a previous misconnection of foul waste from a neighbouring commercial premises to the storm water system that runs through the Sue Noake site alongside the ATP (see red dots in Diagram ---).

On occasions when the site was subject to high levels of rainfall, the increased volume of water needing to be managed caused a breach at the collapsed storm drain, with the result being the distribution of both surface water (flooding) and foul water (sewage) across the ATP surface. These issues are well documented and have been the subject of regular reports to the Council and across social media.

This matter was addressed in July 2020 when an external drainage expert, under the instruction of the neighbouring premises, remedied the misconnection, ensuring foul waste was correctly connected to the foul waste system (red dots in Diagram ---). This correction means that foul waster is now appropriately carried away and will not affect the future usage of the Astro Turf Pitch.

The Council has separately commissioned the repair of the collapsed storm line running the length of the ATP to ensure that the historic surface water flooding issues are remedied. This work will begin mid March 2021, will take approximately three to four weeks to complete and will address issues of prior surface water flooding at the ATP.

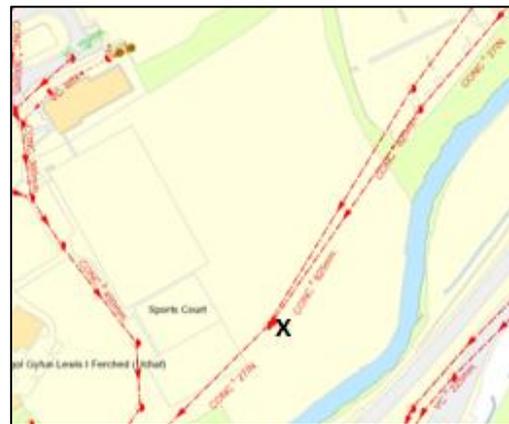
Two manholes (located alongside X in the diagram below) sit above a mainline or trunk sewer and are the responsibility of Welsh Water.

Welsh Water have confirmed that their own records indicate that there have only been two recorded incidents of the manholes shown at X surcharging over the previous ten years. The first of these was in 2014 and the second, the most recent incident, in January 2021. Discussions with Welsh Water this week confirm this to still be the case.

When a breach of this nature occurs, particularly on a trunk sewer, Welsh Water have a number of specific responsibilities. These can be summarised as site containment, decontamination, reinstating the manholes, investigation and remediation.

With regard to the breach at Sue Noake, the area of the surcharge has been cordoned off by Welsh Water (site containment) to enable the elements to begin naturally breaking down any waste material (decontamination). The manholes have also been reinstated.

Welsh Water have begun a detailed investigation of the breach and will return to site this week to continue to explore both upstream and downstream using specialist camera equipment. This will enable Welsh Water to identify the cause and prescribe the necessary remedial action to clear the system and protect against future breaches.

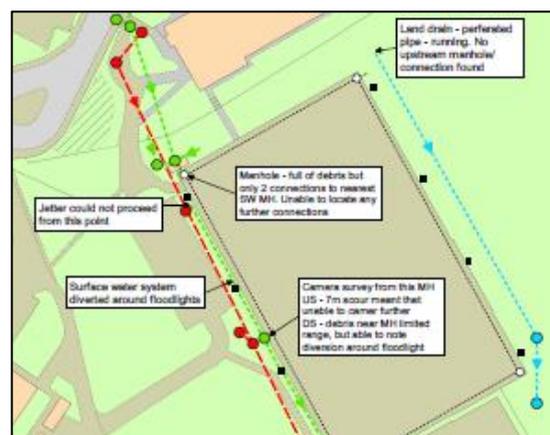
This type of drainage, consistent with that in place at the Trinity 1 pitch, can be connected to the existing land drainage pipe running across the back of the ATP pitch and away from the site (see blue dots in Diagram ---).

Drainage of this nature ensures that any surface water that may occur as a result of significant and sustained rainfall is carried away quickly and efficiently and the pitch above can become usable again very quickly thereafter.

As part of the mitigations being developed in relation to the proposed expansion of Trinity Fields Special School, the Council intends to install herring bone drainage beneath the proposed Sue Noake 2 pitch.

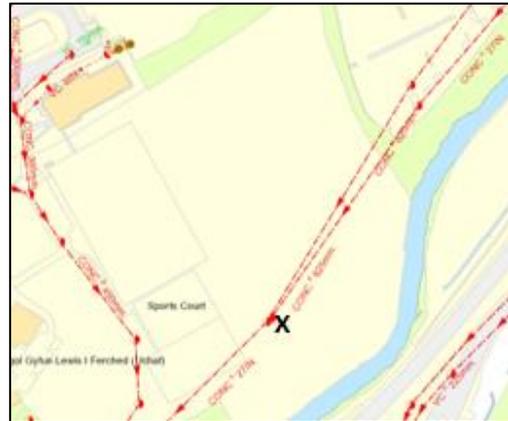
The likelihood of a reoccurrence of the recent surcharge of the manholes at **X** is considered unlikely and the frequency of reports over the last decade would appear to support this position.

The Council will make an application to Welsh Water to relocate the manholes further away from the pitch.

In the interim the Council is also exploring as part of its plans for SN2 the possibility of developing a protective 'bund' around the manholes. A 'bund', essentially, a raised grass bank will be installed between the pitch and the manholes to provide additional protections to the new pitch from any debris that may emerge should the manholes surcharge again at a future point.
